Fibrous

ViskoTeepak Complaint Approach - Article 2

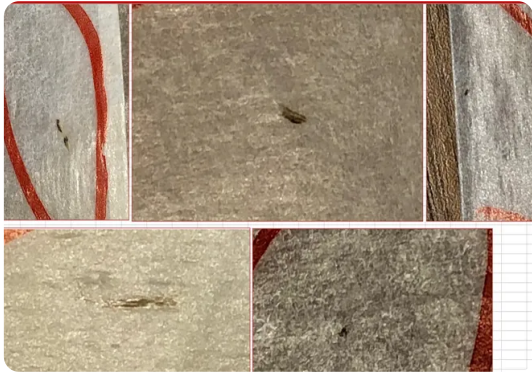
Issue 4 – Unidentified Elements in the Casing

Sometimes the customer happens to notice “black spots” embedded in the casing. Unidentified elements for our customers as shown in the pictures. Customers will usually refer to such unidentified elements as a piece of metal, a hair, or ink.

However, by far, most of the time the analyses show that these spots are actually pieces of wood, i.e. the raw material for cellulose. Harmless in nature, but it looks suspicious.

The basic material we use in our fibrous casing production is the wood that comes from the abaca plant. The wood is chemically treated to obtain liquid cellulose that will be eventually converted into a wide roll of paper. The liquid cellulose is pre-filtered to make it homogeneous and remove any bigger elements. Sometimes, however, very small pieces of wood do slip through the system and show up in the paper used at a later stage to manufacture our fibrous casing.

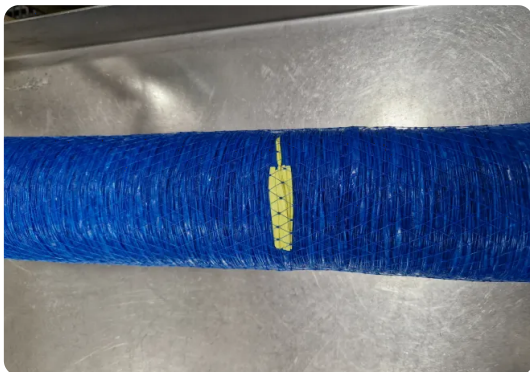
Issue 5 – Pleats on the reel stock resulting in poor printing

At the end of the fibrous extrusion process, the casing is reeled up. This is a very accurate job where tension, direction and workmanship are very important. During reeling, some pleats or folds may show up due to various causes. Most of the fibrous casing at the end of the processing, some folds show up. Most often it's related to incidents detected immediately by the system. Once detected, folded casing is taken out of the process.

Sometimes few folded meters do slip through the manual control. As such reel stock only affects the printed casing.

A second check is implemented during printing, and improperly printed product will show up in the market only in a very limited number of cases.
